Intel® Celeron® Processor in the 478-Pin Package

Specification Update

May 2003

Document Number: 290749-010

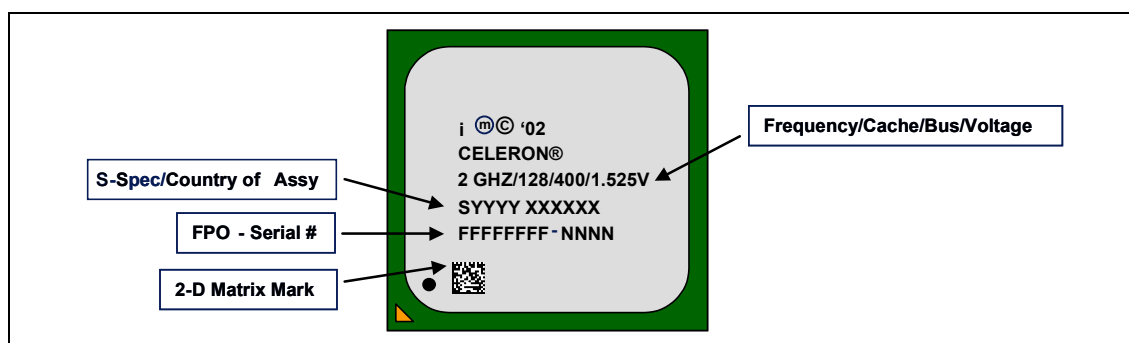
Figure 1. Example Markings for the Intel® Celeron® Processor on 0.13 Micron Process and/or in the 478-Pin Package

The Celeron processor in the 478-pin package may be identified by the following component markings:
